Case Study # 3

Accident Reduction on the 401/416 Ramp using Fixed Automated Spray Technology (FAST)

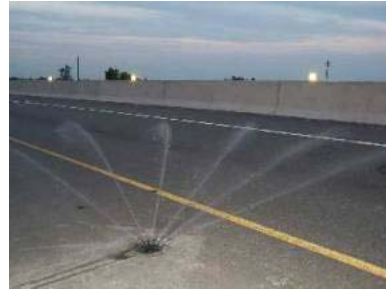
Source: MTO

case with many bridges, the deck tends to freeze before the rest of the adjacent highway sections. Often motorists traveling eastbound and exiting onto the ramp were travelling from unfrozen to frozen conditions at highway speeds. In the year prior to installation of the FAST system, 14 winter-related accidents were recorded on the ramp.
